**LEVEL**  
**TAMARACK LAKE DAM "A"**

**PHASE I INSPECTION REPORT**  
**NATIONAL DAM INSPECTION PROGRAM**

TAMARACK LAKE DAM "A"  
CRAWFORD COUNTY, COMMONWEALTH OF PENNSYLVANIA  
NDI No. PA 00181  
PennDER No. 20-47A  
SCS No. PA 461A

Date: 11 May 1979

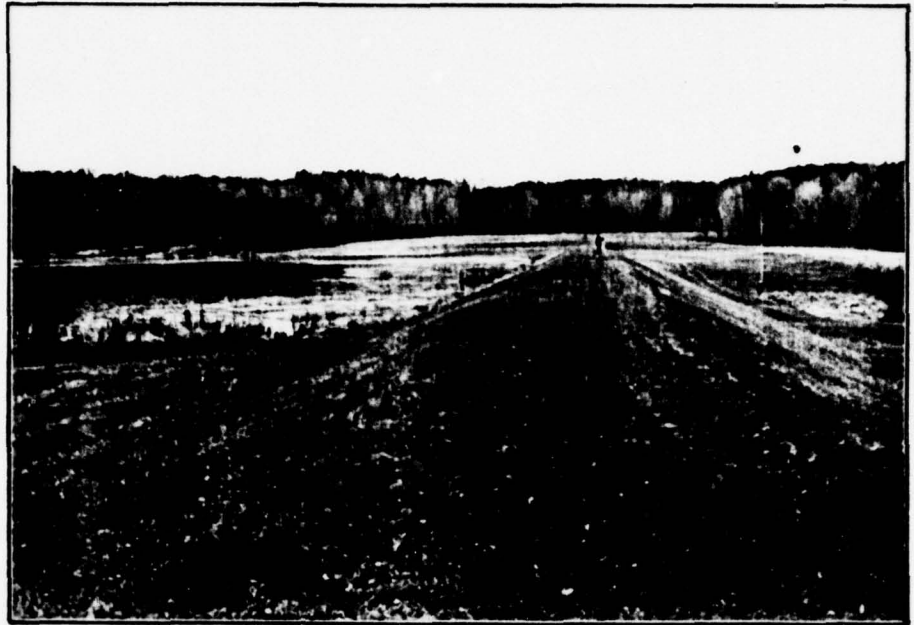
Overall View of Dam from Right Abutment toward Emergency Spillway  
and Diversion Dam.

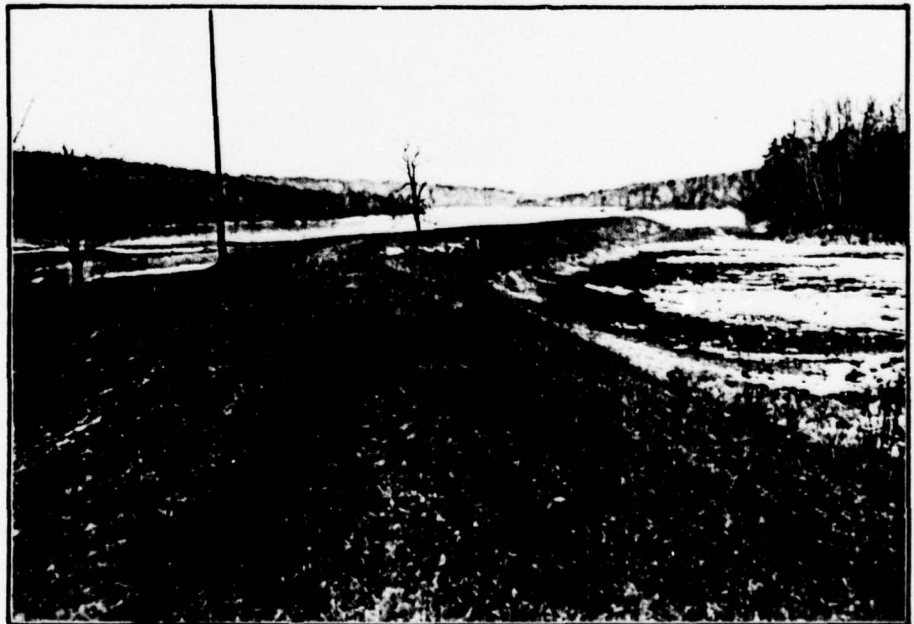
Overall View of Diversion Dam Looking towards Reservoir

- c. Diversion Dam - Some minor erosion was observed on the crest of the dam. No other significant deficiencies were noted. The pond drain was open at the time of inspection and no water was impounded behind the dam.

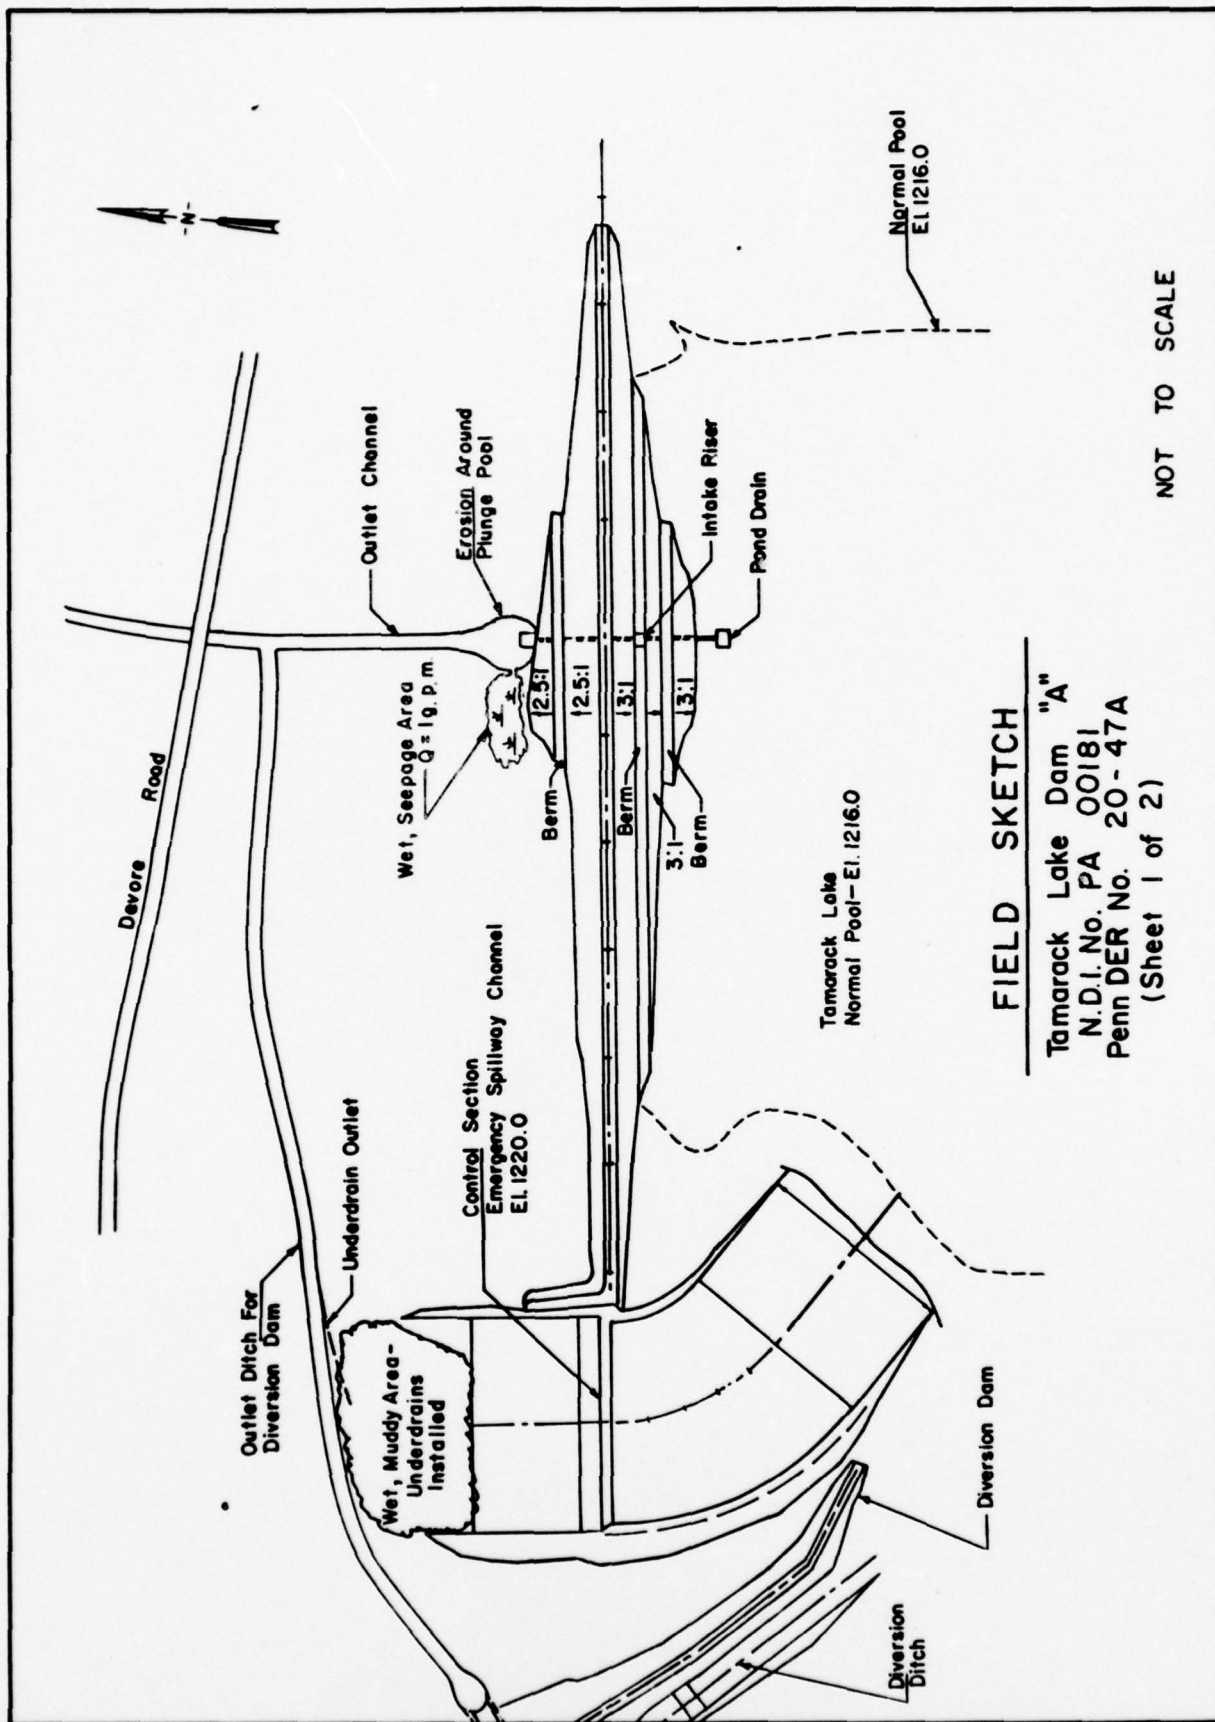
Tamarack Lake Dam "A"  
 N.D.I. No. PA 00181  
 Penn DER No. 20-47A  
 (Sheet 1 of 2)

NOTE: Pond Drain Was Open At  
The Time Of Inspection  
And There Was No Water  
Impoundment

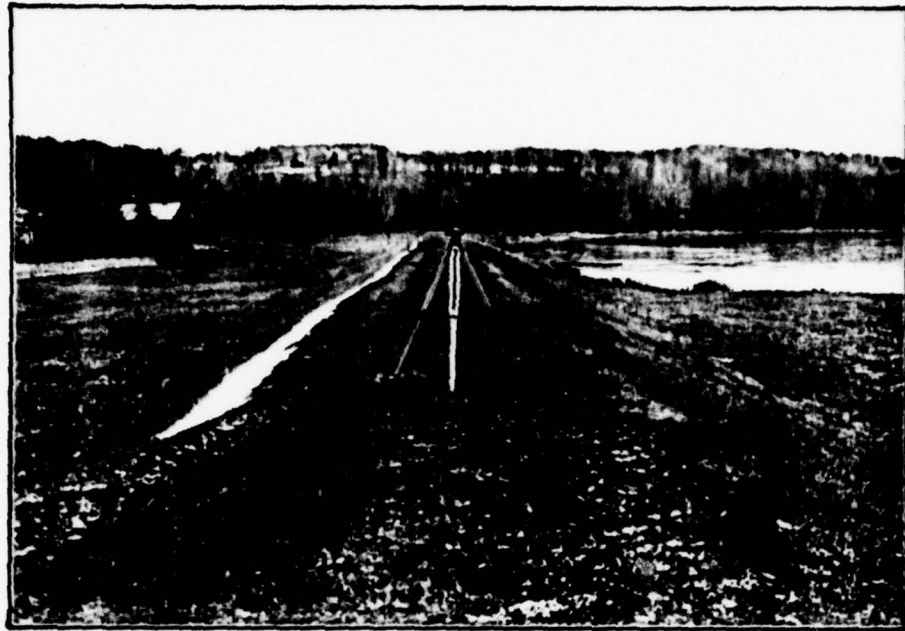
**PHOTO 1. View of Dam from Junction of Embankment and  
Emergency Spillway**

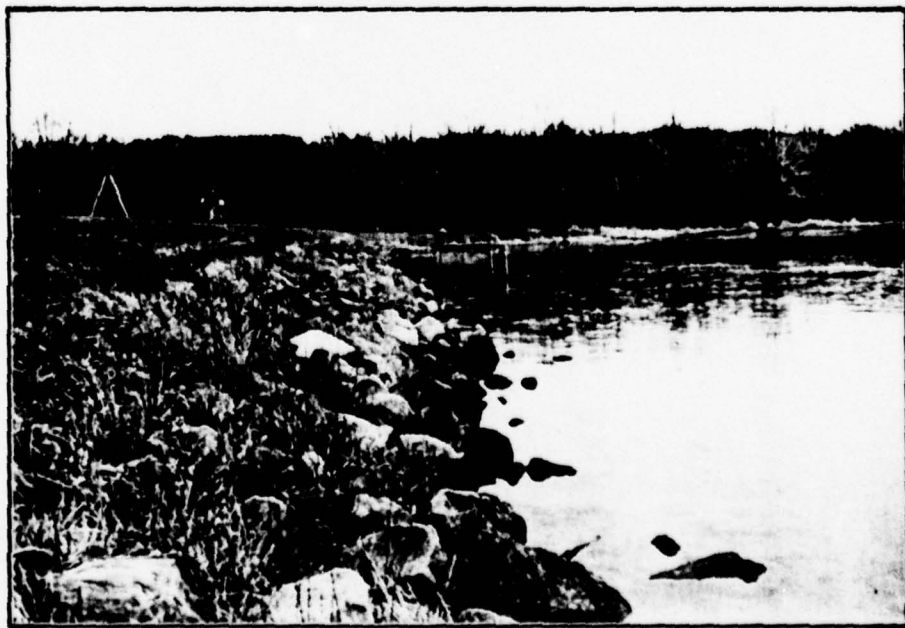
**PHOTO 2. View of Principal Spillway Intake, Upstream Slope,  
and Riprap Protection**

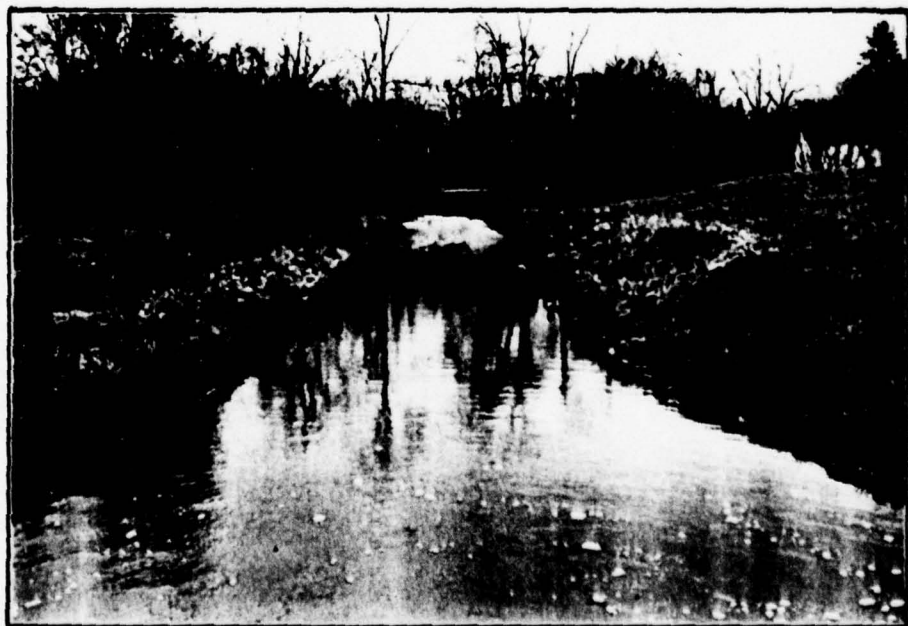
**PHOTO 4. View of Outlet Channel and Downstream Roadway Culvert**

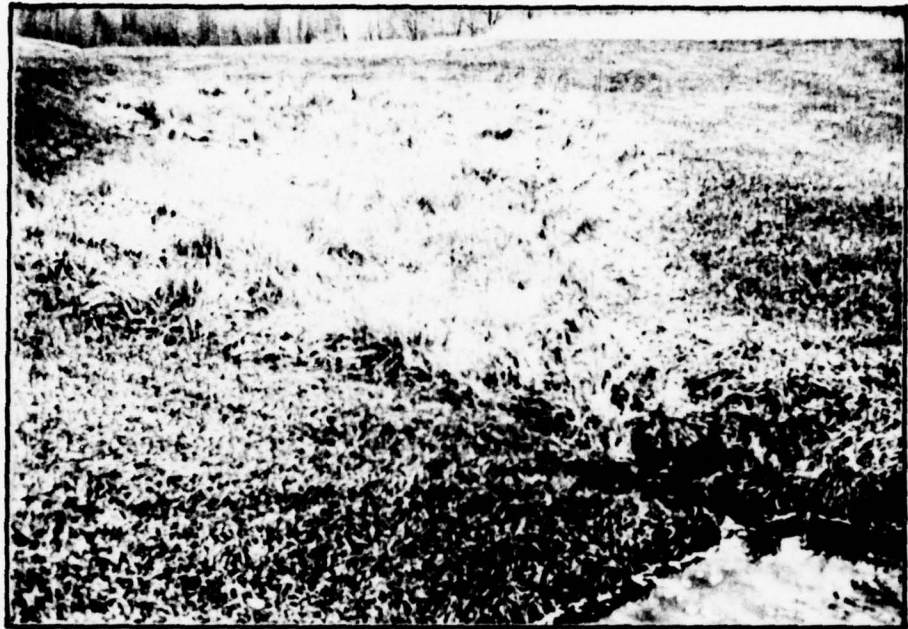
- a. General - The dam and its appurtenant structures were found to be in good overall condition at the time of the inspection, with the exception of the seepage area noted at the downstream toe of the embankment left of the outlet conduit. Noteworthy deficiencies observed are described briefly in the following paragraphs. The complete visual inspection check list and field sketches are given in Appendix A.

- a. Visual Observations - The marshy area and seepage observed during the visual inspection is not considered detrimental to the stability of the dam according to the conditions present at the time of inspection.
- b. Design and Construction Data - Calculations of embankment slope and foundation stability were not available for review. However, a summary report from the SCS Soil Mechanics Laboratory at Lincoln, Nebraska dated 14 April 1961 contained the following information:

**PHOTO 5. View of Seepage Area Located to Left of Outlet Conduit**

- 1) Install a weir to monitor the seepage.
- 2) Provide proper inspection access to the vertical drain on the left side of the outlet conduit.
- 3) After access has been provided, a qualified professional engineer should inspect the vertical drain and provide recommendations as necessary.
- 4) Periodically inspect and maintain the vertical drains in the future as necessary.
- 5) Repair minor erosion areas on the dams. Efforts to prevent use of motorcycles and other vehicles on the dams and in the spillway should be increased.
- 6) Install properly designed riprap or other measures to prevent erosion around the plunge pool.

outlet pipe for the vertical drain, the necessity of any maintenance of the vertical drain or the necessity for an alternate seepage control measure, and develop additional recommendations as necessary.

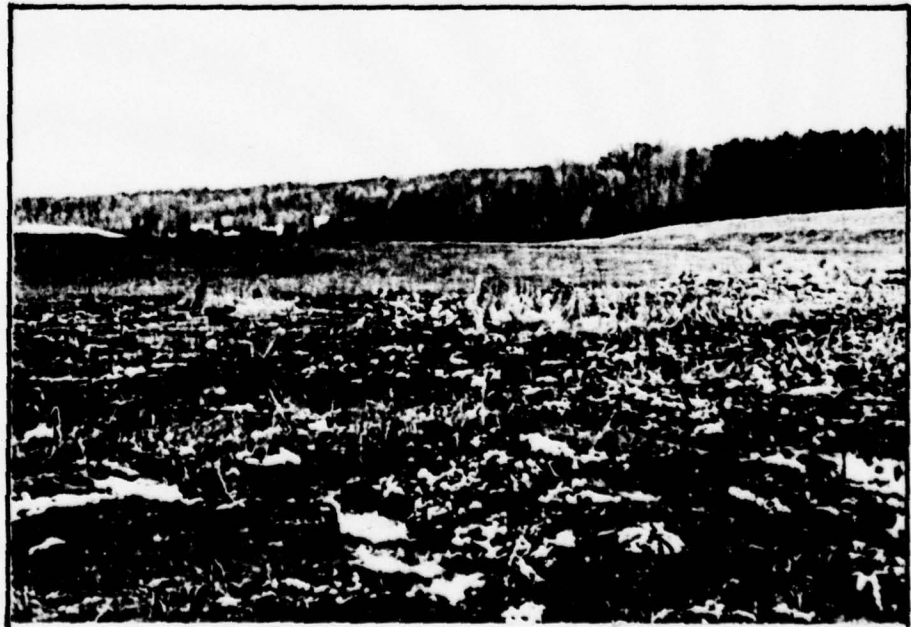
**PHOTO 6. View Looking Upstream at Emergency Spillway Channel  
(Diversion Dam Forms Left Abutment of Emergency  
Spillway Channel Located in Right Portion of Photo)**

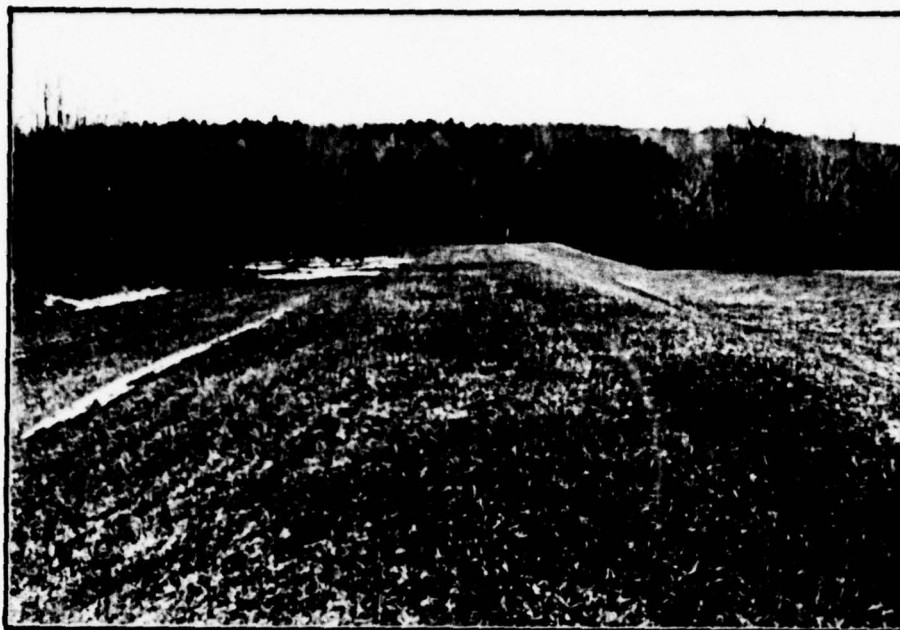
**PHOTO 7. View Looking Downstream from Reservoir at Diversion Dam  
(Emergency Spillway Channel in Right Portion of Photo, Diversion Ditch in Left  
Portion of Photo, Drained Diversion Pond in Upper-Left Center Portion of Photo)**

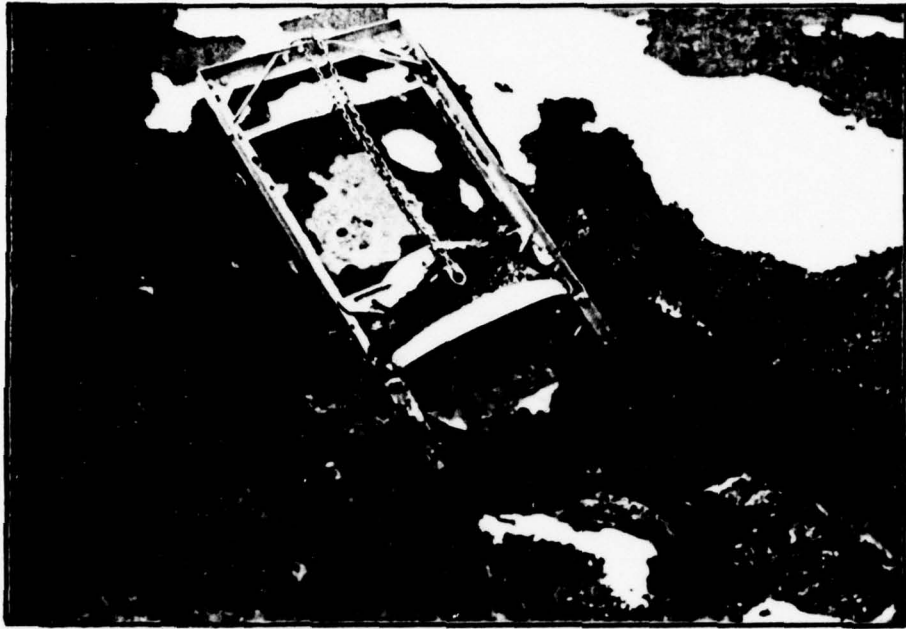
**PHOTO 9. View of Slide Gate Pond Drain Inlet for Diversion Dam Pond**

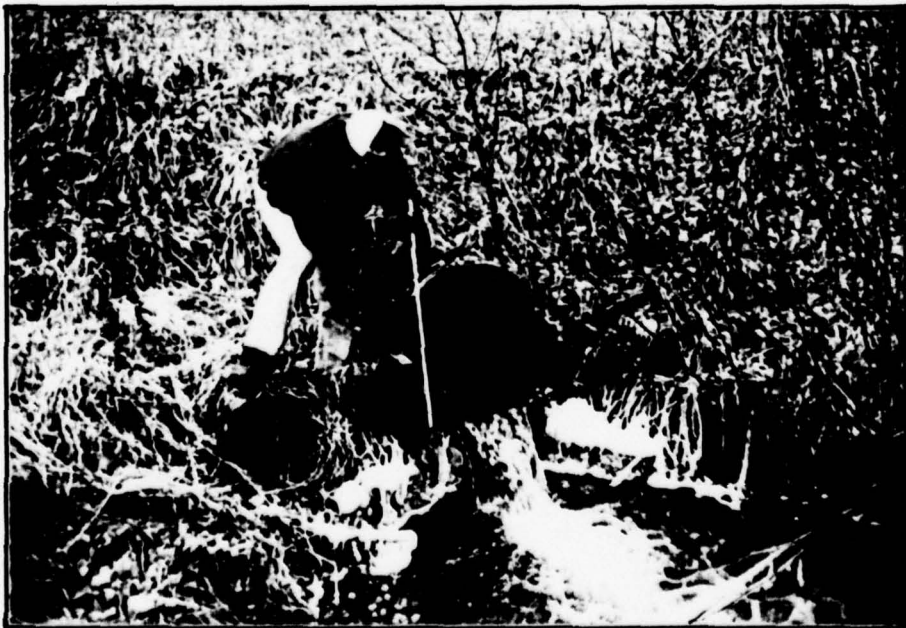
**PHOTO 10. View of Pond Drain Outlet Conduit and Drain Outlets**
